Vremski Britof landslide sanitation

landslide rehabilitation

Vremski Britof, Slovenia

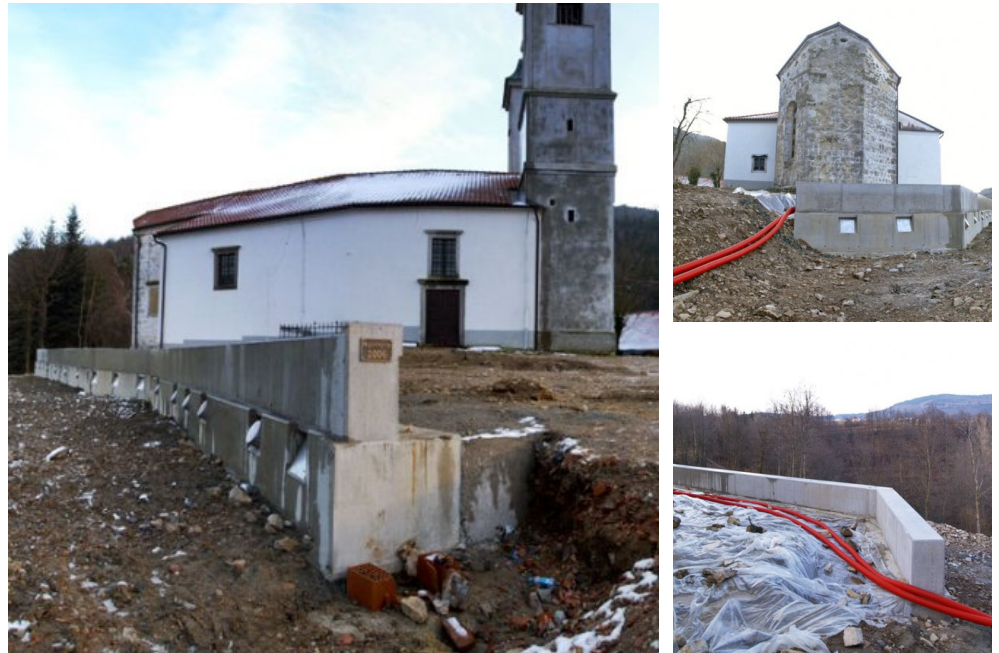
The historical building is built on the flat plateau which is severely damaged by the landslide. The landslide before the sanitation was about 1 meter away from the part of the building which contains the wall paintings more than 400 years old. The first task was strengthening the structure. The phase that followed was the stabilization of the slope. A combination of the well defined measures was predicted, to stabilize the slope without endangering the structure. Draining of the slope, piloting and anchoring of the horizontal beam and reconstruction of the lost material was designed.
